Manhole Inspection Summary

Manhole # S3500_038MH

Insp Date: **1/26/07 9:05 AM**

Location Address: **2317 HARGROVE AL**

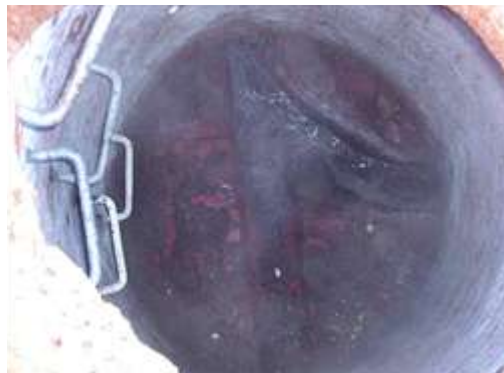
Top View

Evidence of surcharge - Bench debris.
Channel debris.

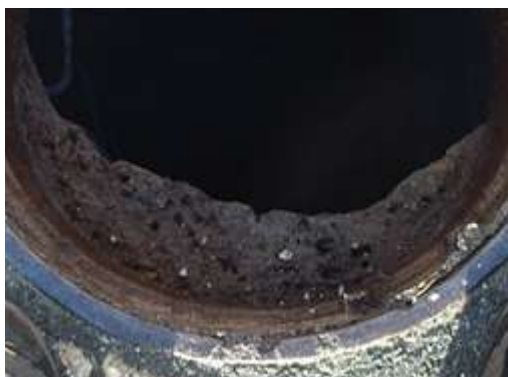
Defect

Frame Offset: **5** (in.)

☒ **Leaks**

Infiltration: ☐ None ☒ **Joint** ☐ Cracks ☐ Mortar ☐ Roots ☐ Wall

Frame leaks. Frame offset. Adjustment
infiltration.

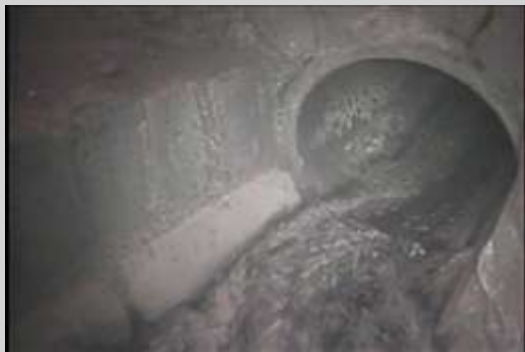
8 in. Circular Gravity Sewer Pipe Out @ 12 O'Clock

Deposits: ☐ None ☐ Mud ☐ Sludge ☐ Debris ☒ Grease

Silt Depth: **0** (in.) Deposits Extent: **Light**
